BRUGG CABLE MESH ROCKFALL FENCE

FINAL REPORT

Experimental Features
Project No. OR 90-03

Shellrock Mountain
Columbia River Highway (Interstate 84)
Hood River County
Federal Aid # IR-84-2(31)052

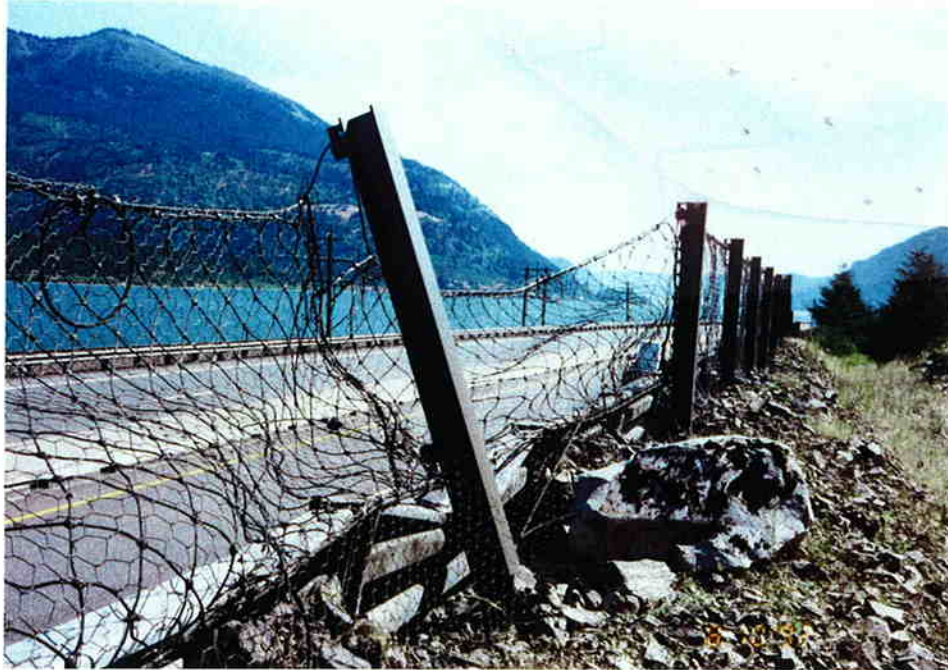
On August 8, 1992, a 1.7-ton (1.5-metric ton) boulder hit the fence (Figure 2.1). The boulder dislodged from the cliffs above the talus, bounced and rolled down the slope (Figure 2.2) and impacted the 6.5-foot (2.0 m) high fence at Sta. 567+80, about mid-height. The distance between the observable bounces were surveyed (Figure 2.3) and found to vary from five to fifty feet (1.5 to 15 m) along the slope. The final bounce was in the fallout area near the toe of the slope (Figure 2.4). The rock impacted the fence three feet (0.9 m) from a post, imparting much of its force to the post and its foundation, causing the foundation to rotate approximately 20 degrees. The fence, however, stopped the rock and prevented it from entering the travel lanes.

The rock was approximately the same size as the design rockfall, but due to its trajectory the calculated energy was less than the 150,000 foot-pound (200 000 joules) design energy. Although the impact was less than the design energy, the foundation rotated. The rotation was due to the post not breaking-away as designed and the foundation's inability to resist the impact moment without the tie-backs.

**Figure 2.1 The Brugg Cable Mesh Rockfall Fence after the August 8, 1992 rockfall impact.
(The posts are 8 feet high) (2.4 m).**

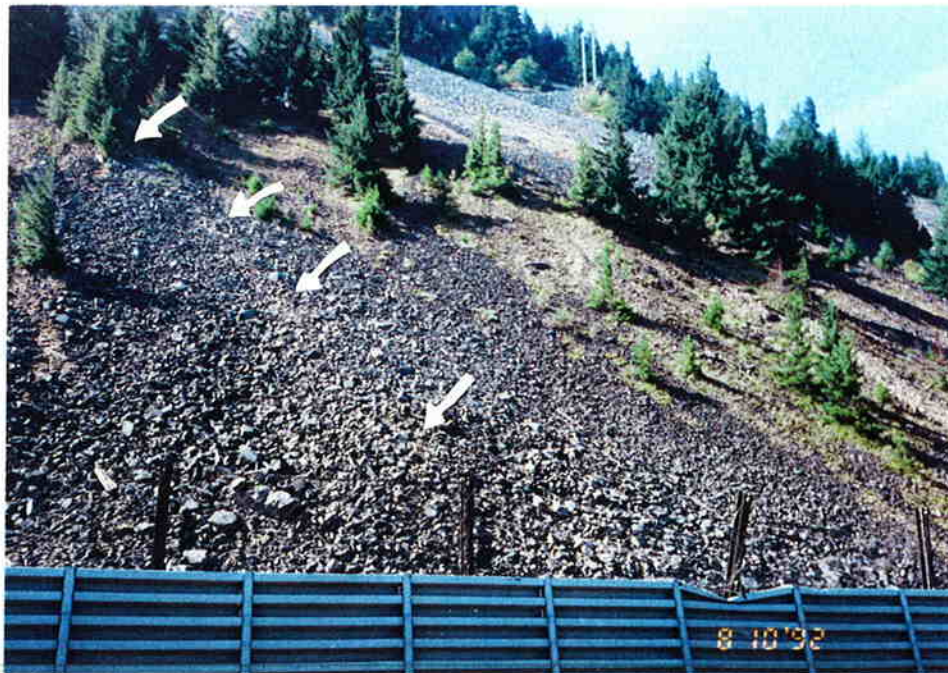
Figure 2.2 Rock bounce marks on the talus slope.

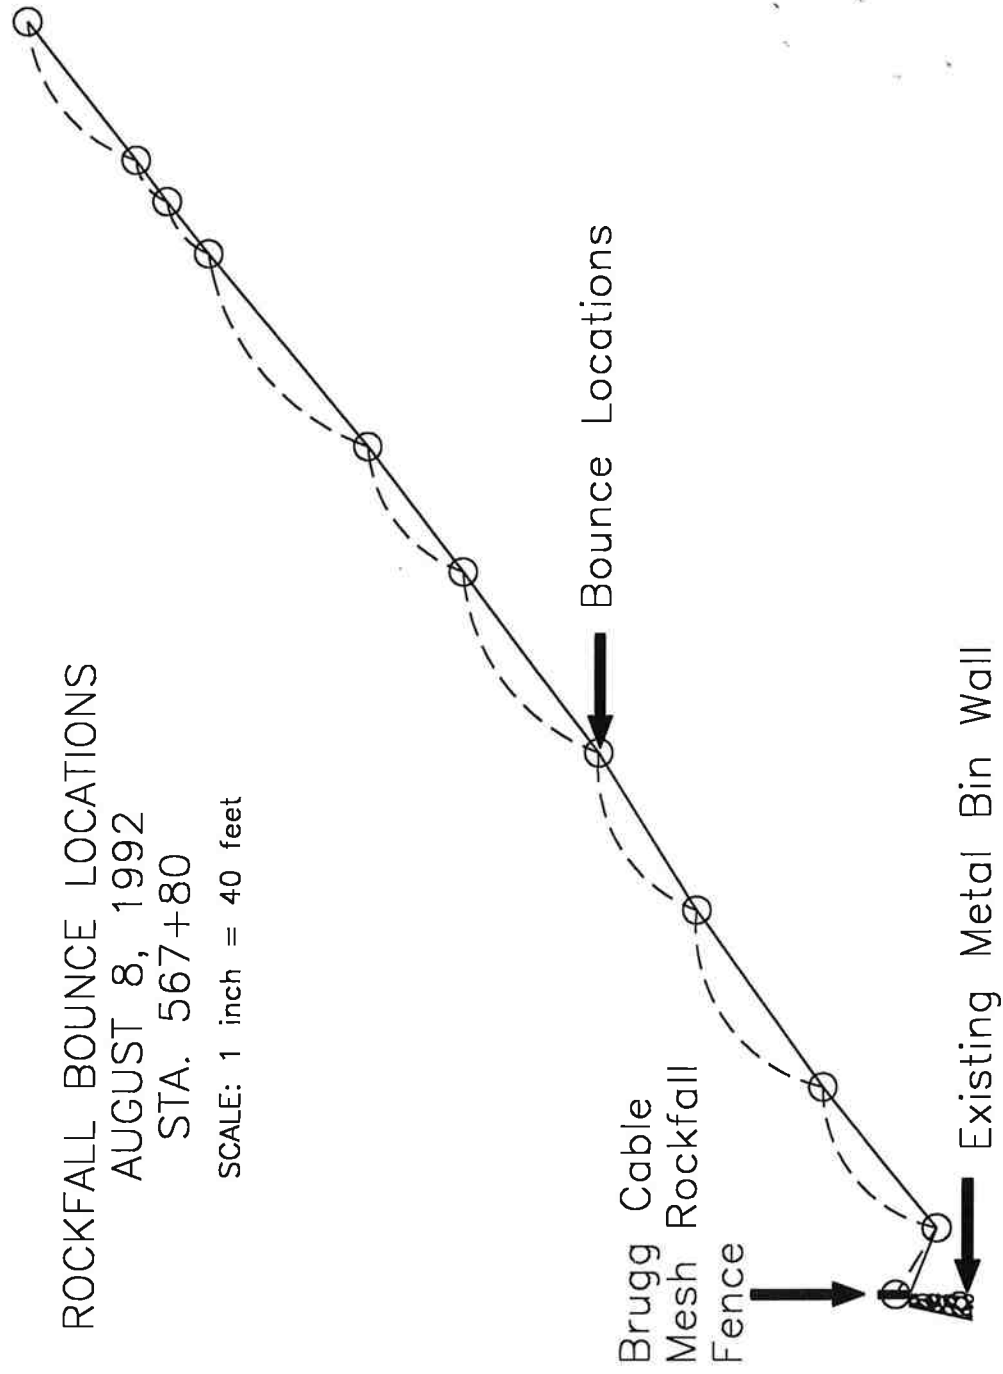
Figure 2.3 Rockfall bounce locations at STA 567+80

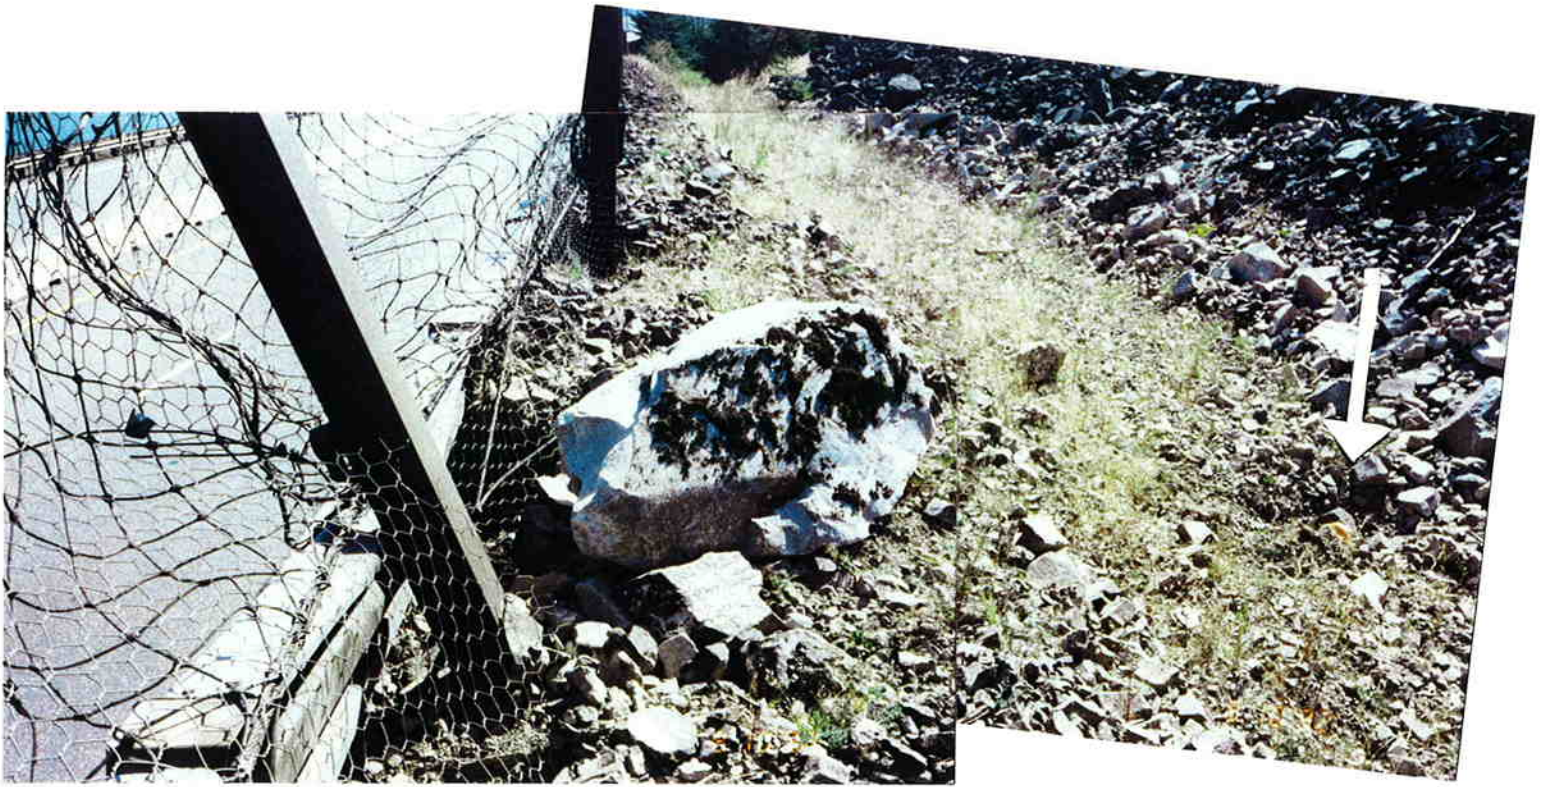
Figure 2.4 Final bounce in the fallout area.

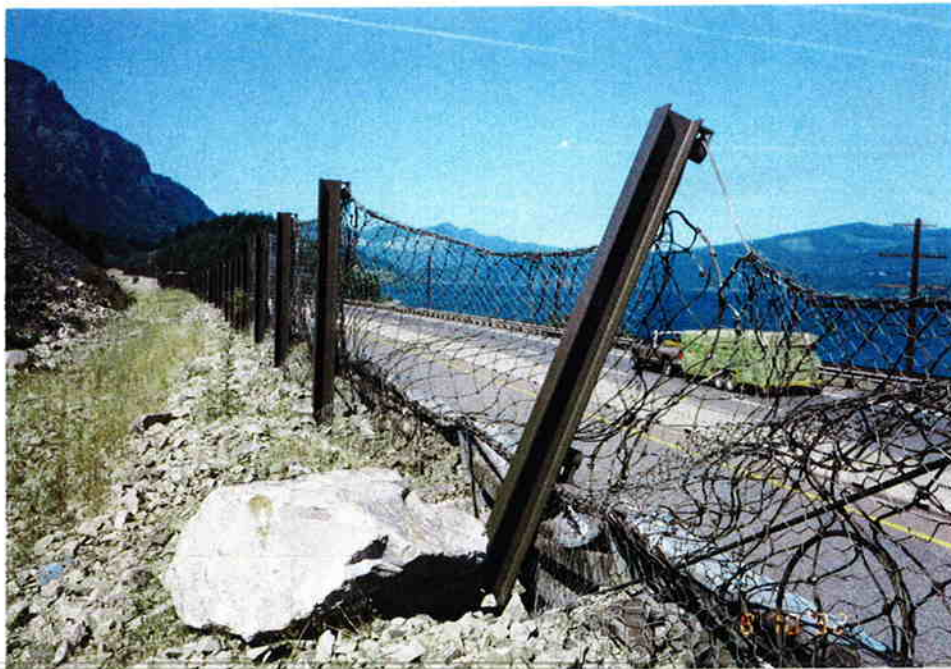
The Brugg Cable Mesh Fence was damaged as it dissipated the energy of the rockfall (Figure 2.5). The damaged portions of the fence are shown in the typical drawing in Figure 2.6. The following is a list of the damage:

1. The upper friction brake was pulled 22 inches (560 mm) (Figure 2.7).
2. The lower friction brake was pulled one inch (25 mm).
3. The seam rope pulled five inches (130 mm).
4. Three 'C' type cable clamps opened.
5. The post and foundation nearest the impact rotated 20 degrees, with no damage to post attachment bolts.

6. The bolt for the lower flange (for lower perimeter cable) bent.
7. The metal bin wall cap was damaged by the post.

Figure 2.5 The damaged fence.

The fence was not permanently damaged and only minor repair was required. The contractor that initially installed the fence repaired the damage. The repair required removing the mesh section, digging out and resetting the foundation, resetting the upper friction brake and perimeter cable, and reattaching the mesh section. The cost of the repairs was \$4,400. Figure 2.8 is a photo of the repaired fence.

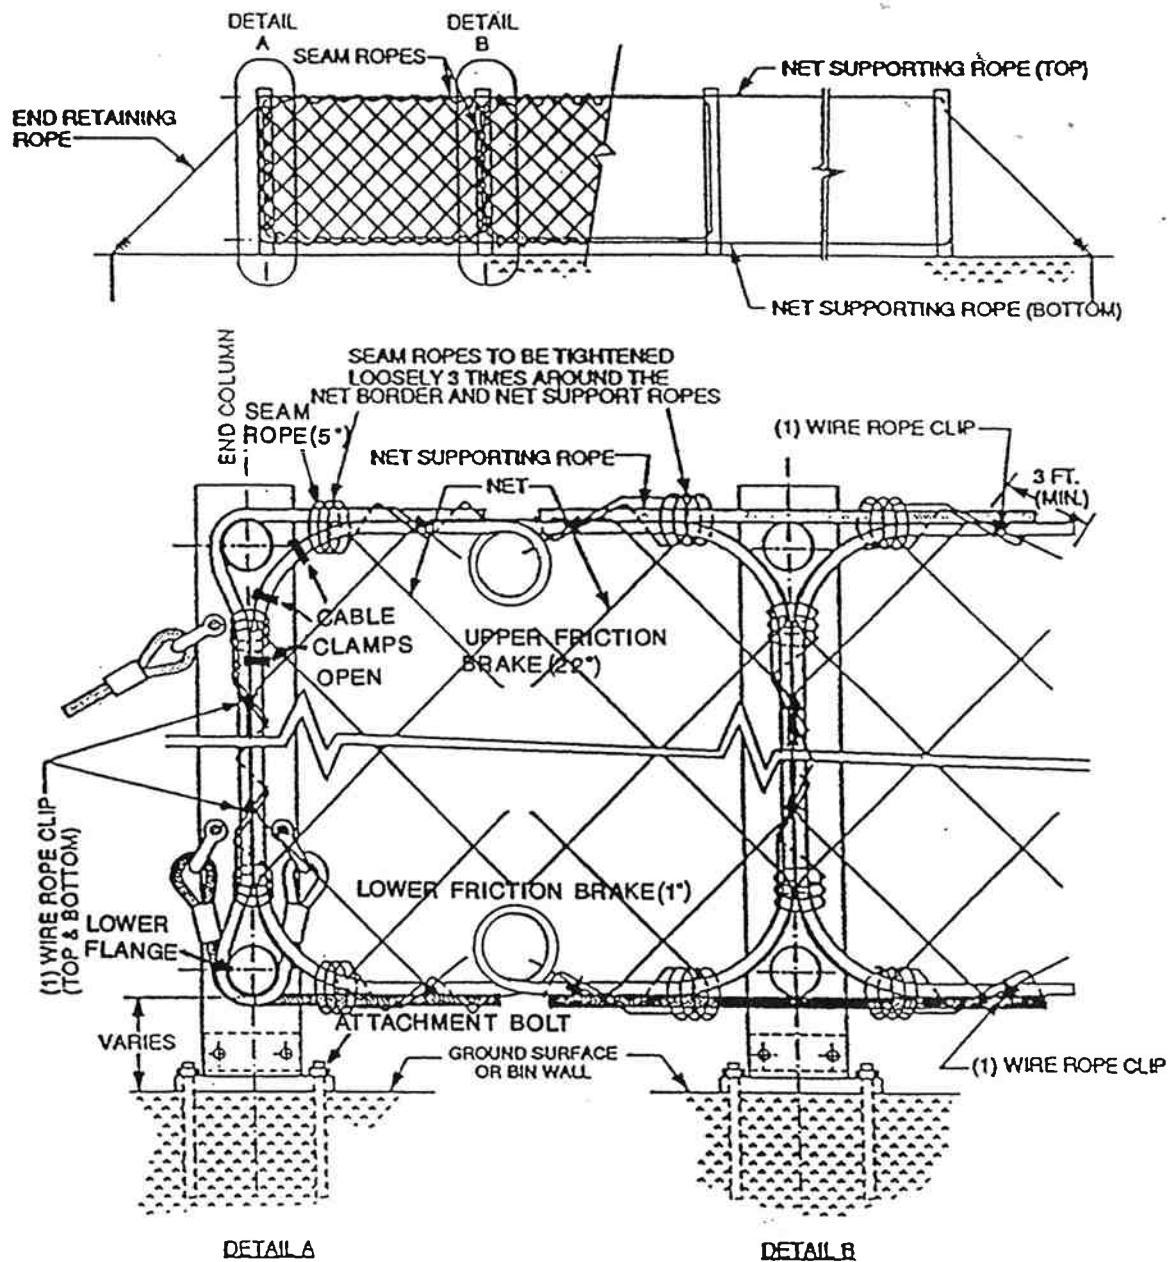
TYPICAL WIRE ROPE NET
INSTALLATION DETAIL

Figure 2.6 Typical detail with damage description.

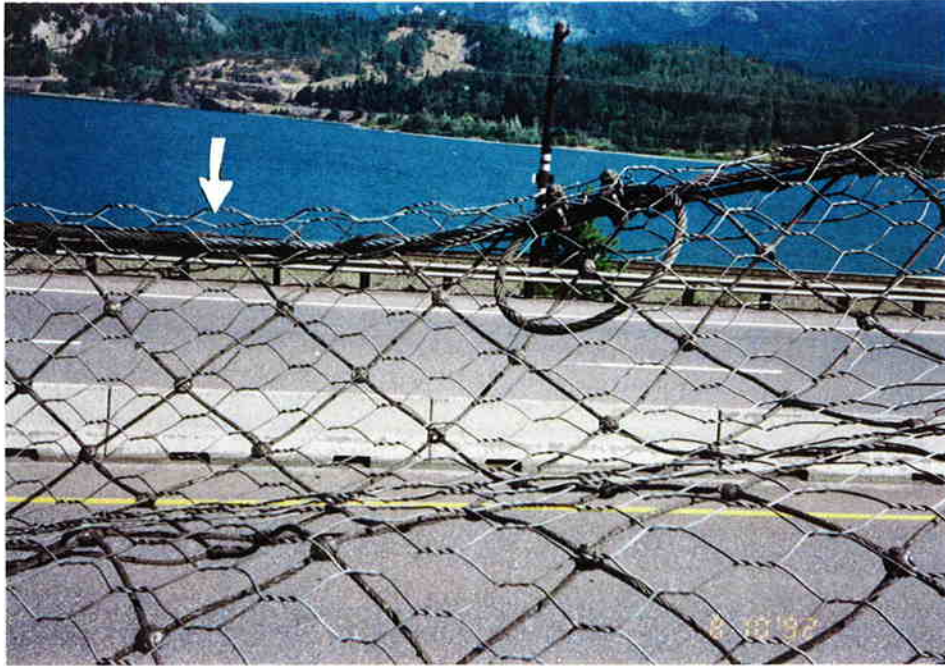
Figure 2.7 The top friction brake pulled 22 inches (560 mm).

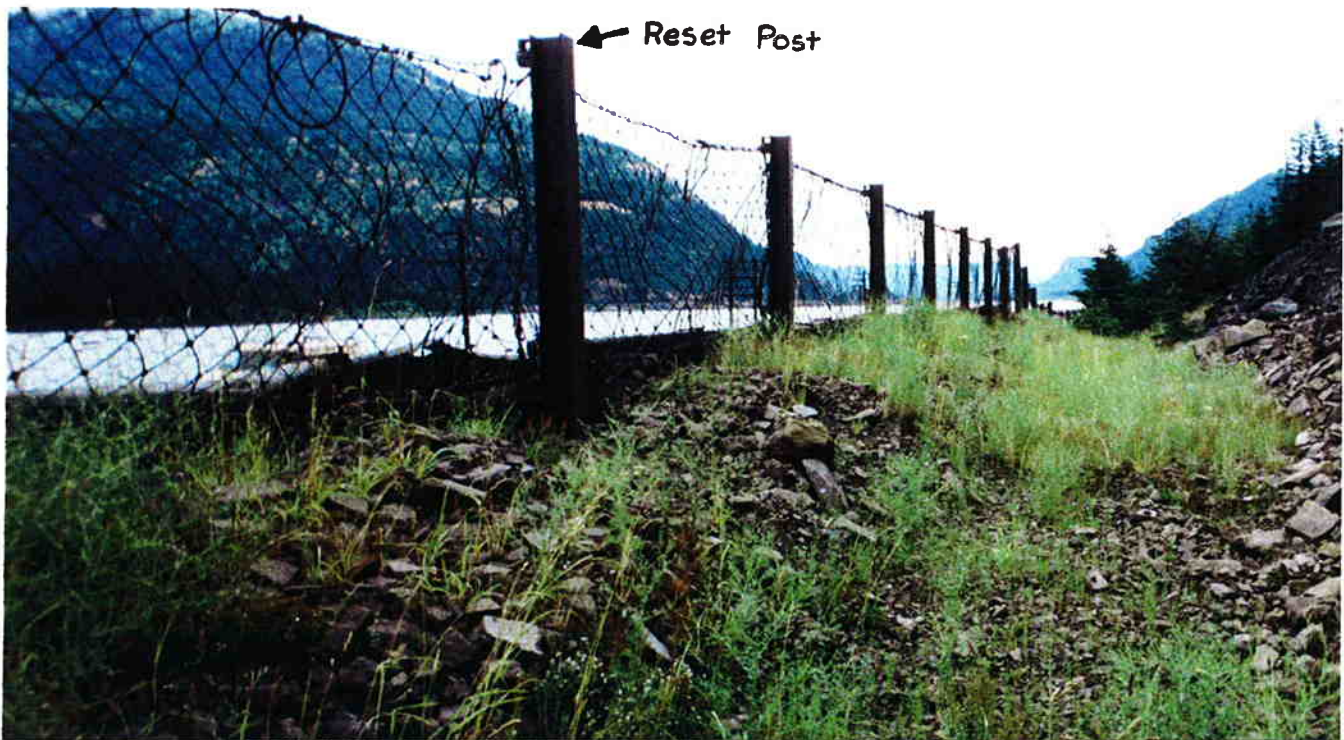
Figure 2.8 The repaired fence.

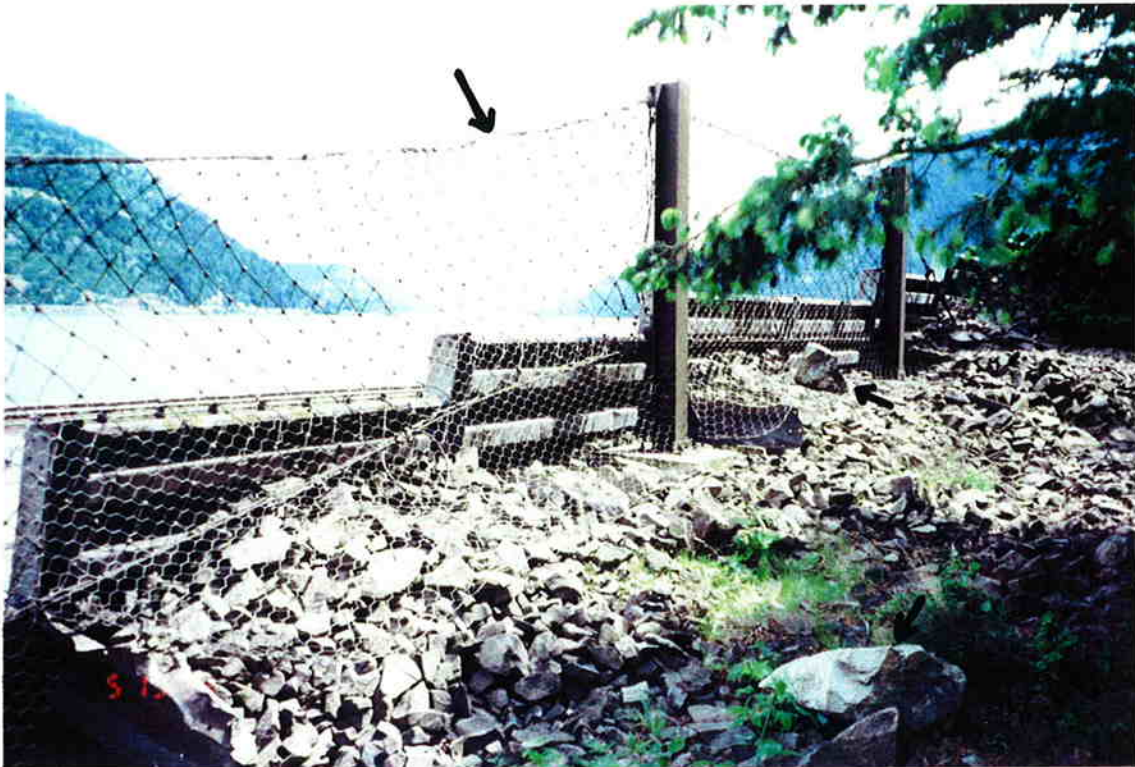
Sometime during the winter of 1993 -1994 a boulder impacted the second to last mesh section fence approximately Sta. 578 + 75 (Figure 2.9). Other rocks associated with this rockfall were also in the fallout area (Figure 2.9). The boulder weighed approximately 750 pounds (340 kg) with dimensions 2.3' x 2' x 1' (0.70 m x 0.61 m x 0.30 m) (Figure 2.10). The impact was located one foot (0.3 m) from the top of the fence and 5.5 feet (1.7 m) from the eastern post (Figure 2.11). The slope distance of the last bounce from the southern edge of the fallout area was approximately 40 feet (12 m).

Figure 2.9 Looking east at the impacted mesh section. The boulder in the foreground impacted the fence. The boulder in the background did not, it rolled up to this position.
Photo taken 5/13/94.

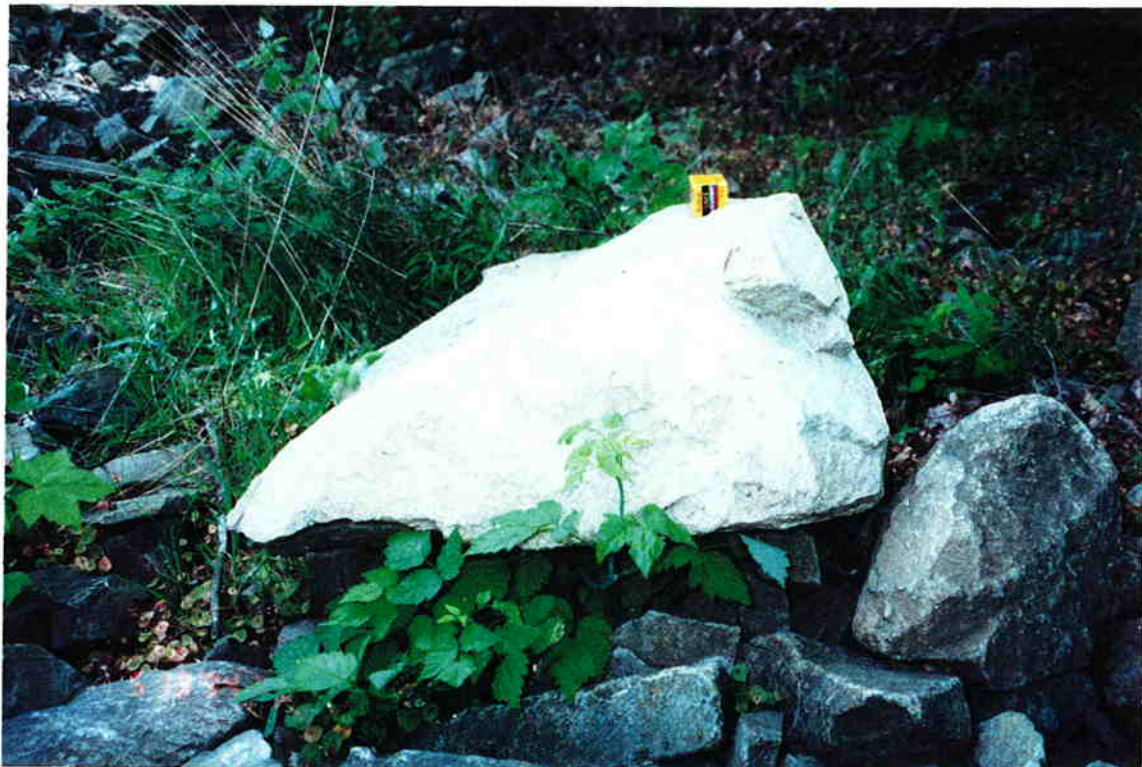
Figure 2.10 The boulder that impacted the fence.
Photo taken 5/13/94.

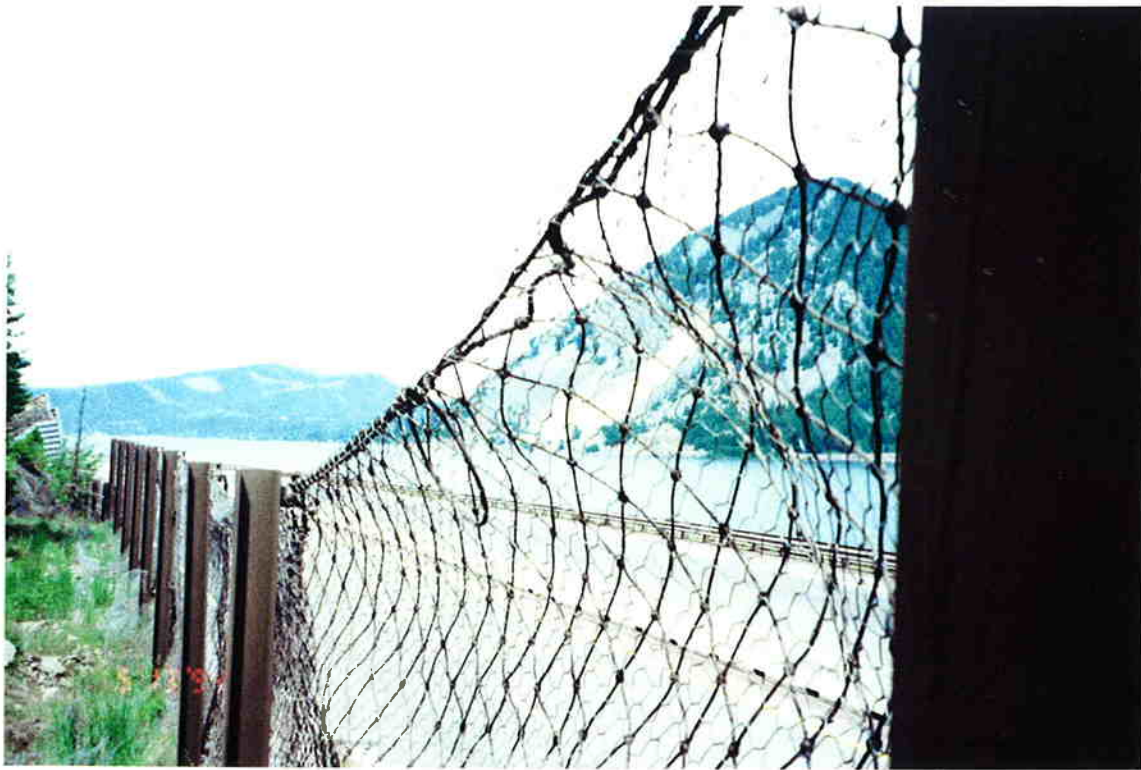
Figure 2.11 Looking west at the location on the mesh section of the impact.
Photo taken 5/13/94.

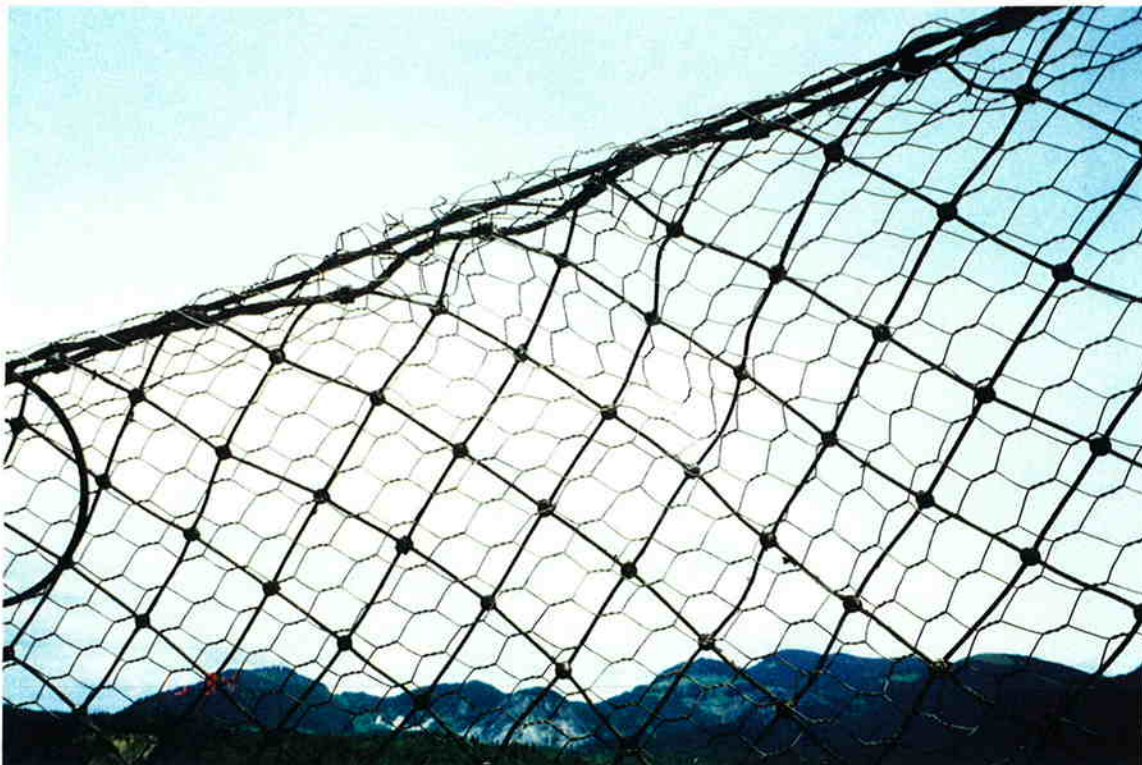
1. Distortion of the cable and the gabion mesh (Figure 2.12).
2. On the impacted section, the upper friction brake slipped one inch (25 mm) (Figure 2.13).
3. On each adjacent mesh section, the upper friction brake slipped 1/2 inch (13 mm).
4. The lacing rope was stretched on the impacted section.
5. The eastern post on the impacted section rotated two degrees.

Figure 2.12 Distortion of both the cable and gabion mesh
Photo taken 5/13/94.

This damage was only superficial and required no repair.

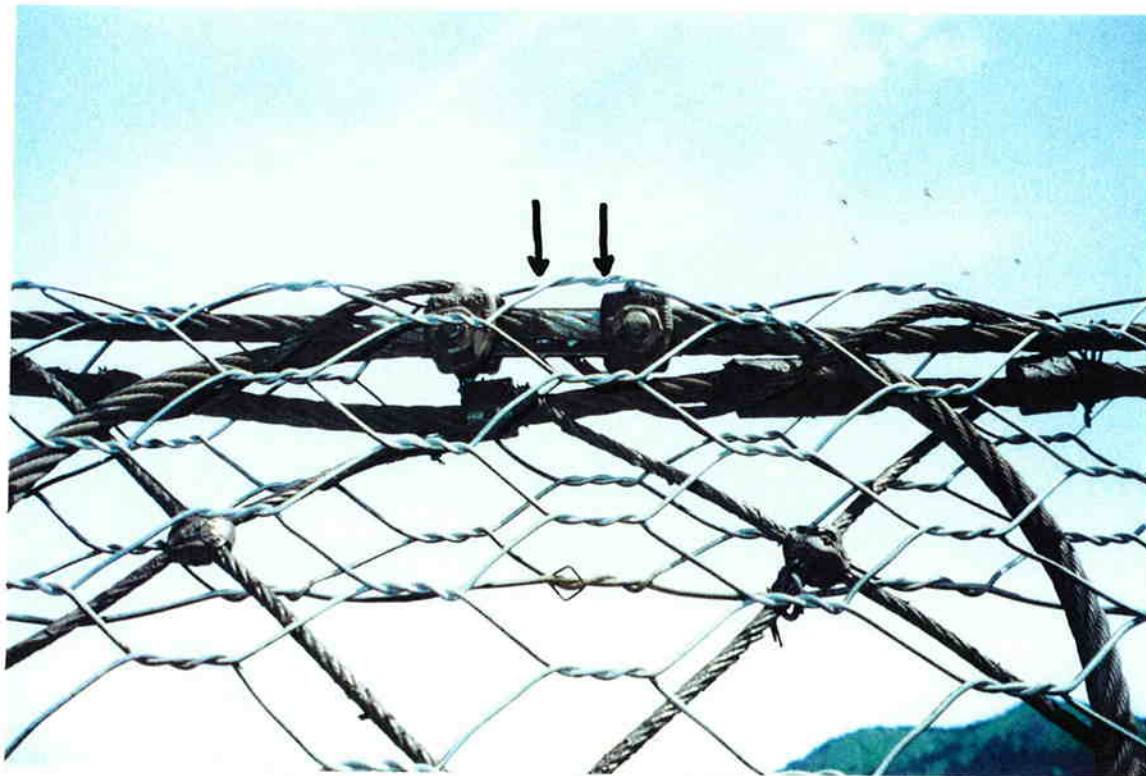
**Figure 2.13 The slip on the upper friction brake.
Photo taken 5/13/94.**
